Report: 1656brittain

Building Inspection Report

Date of Inspection: October 24, 2023
Property Address: 1656 Brittain Avenue.
Deland, Florida 32720

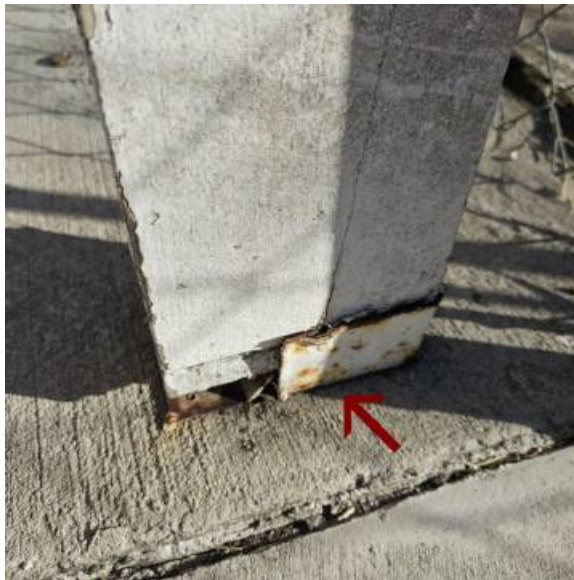
REAR LEFT PORCH: The following was noted at time of inspection:

- 1. Deterioration noted at base of posts of the rear porch covering. The column is loose, and should be corrected as needed.**
- 2. Beam damage/wood rot is noted along the top beam over the rear left porch. This should be repaired as needed.**

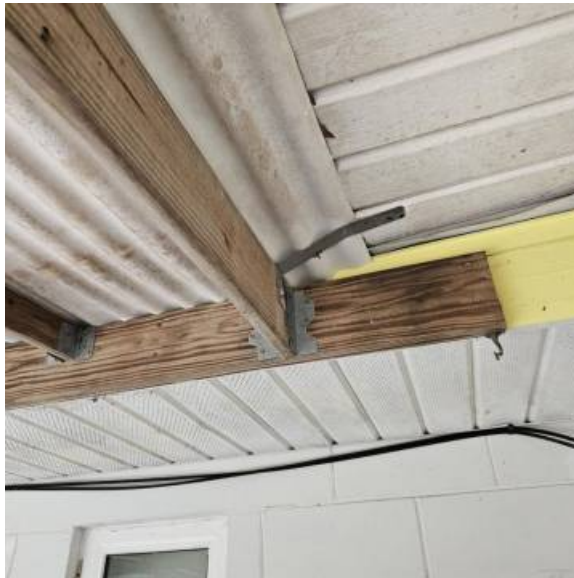
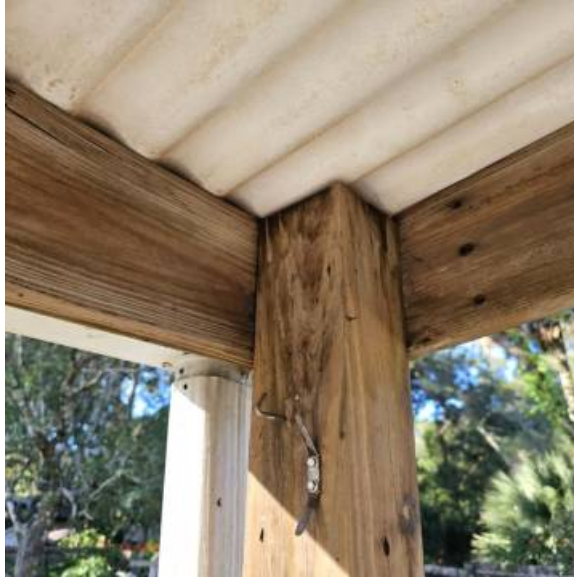
REAR RIGHT PORCH: The rear right porch construction was completed in such that does not meet proper requirements. The framing is not properly attached to the header along the main wall properly; the header and beams are secured with a screws (screws are not designed to maintain levels of weight).

In addition the framing around the porch are not properly supported with the column. Measure to improve construction methods are suggested.

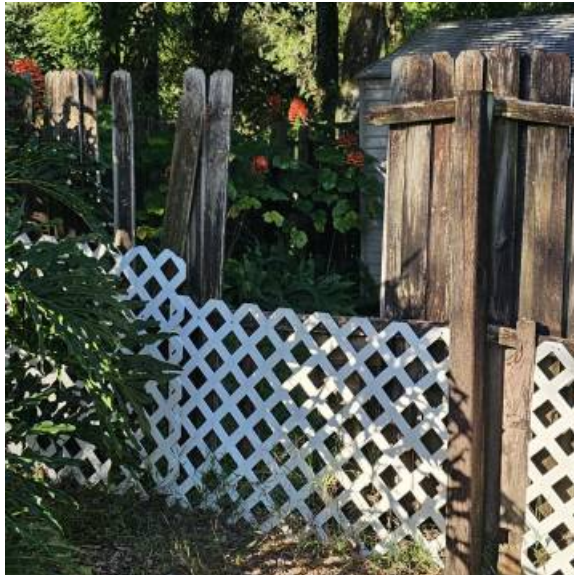
Loose/rotted posts are noted to multiple areas of the fencing material, repair/replace as needed. The fencing was not inspected/included since inspector was unable to determine ownership. Inquire with seller about property lines and fence ownership.

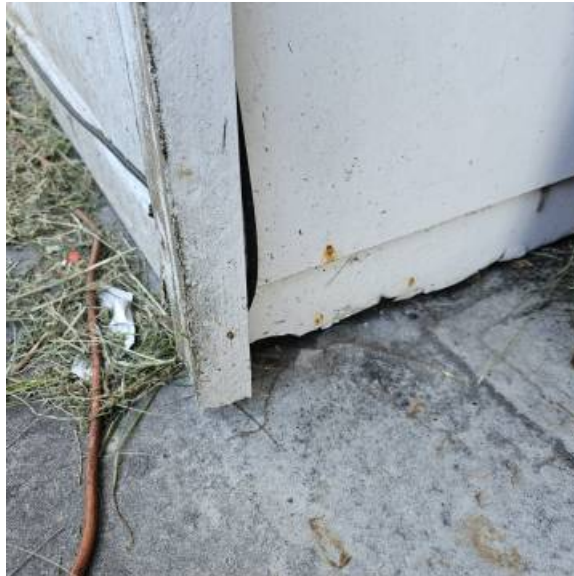
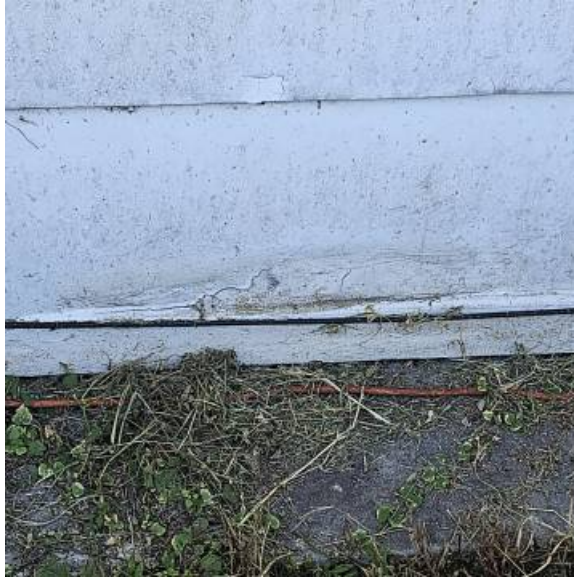
- > front panels lower
- > rear bottom panel of the left porch

These areas should be repaired/replaced as needed.

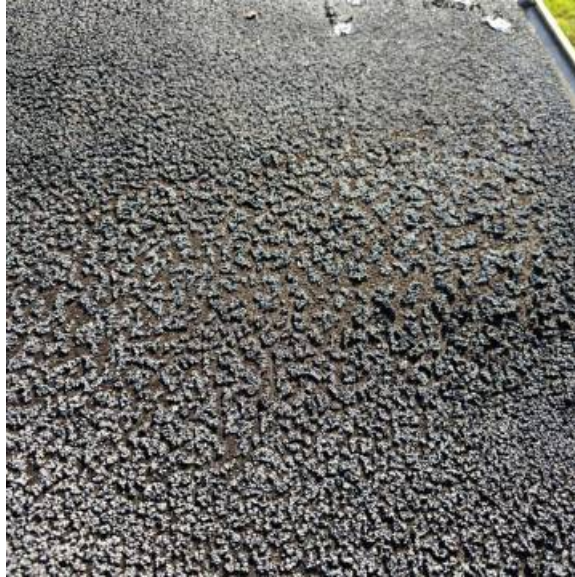
The roof over the sun room is in fair overall condition. The sun room roofing material is a metal insulated porch roof like material

with rolled roofing over the metal. The rolled roof material is beginning to show signs of wear and aging. Cracking and clawing of shingles are the result of long term weathering and an advanced shingle age. Felts are showing through and granular loss is noted. Roof appears to be at/near the end of its useful life, Anticipate the need to replace the roof covering in the not too distant future. A licensed roofing contractor should be called to make further evaluation and repairs as needed.

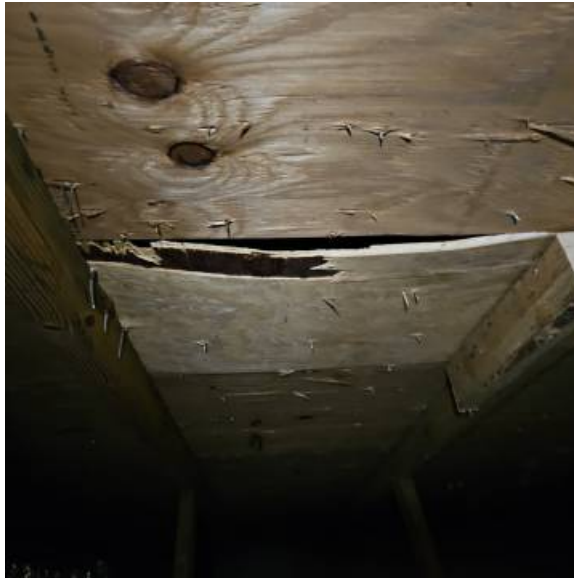
The builder did not install ply clips during installation to a section or roof decking at the rear hip, which may result in sagging at the joints of the sheathing. This should be corrected to properly support the two plywood panels that intersect.

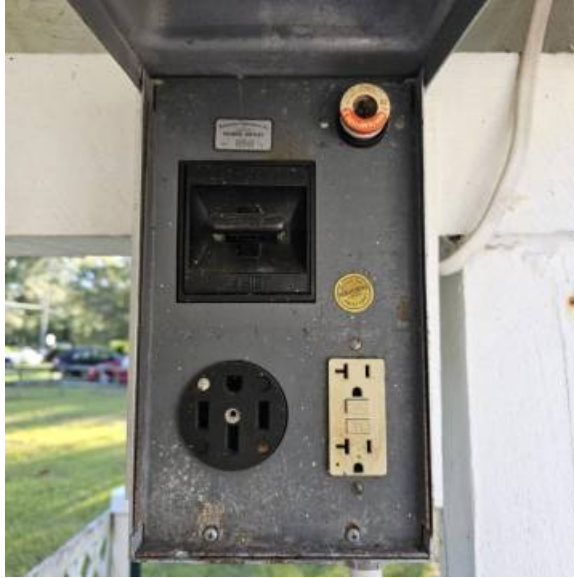
CARPOR: The carport breaker is an older feed with fuse disconnect. This should be replaced with approved material.

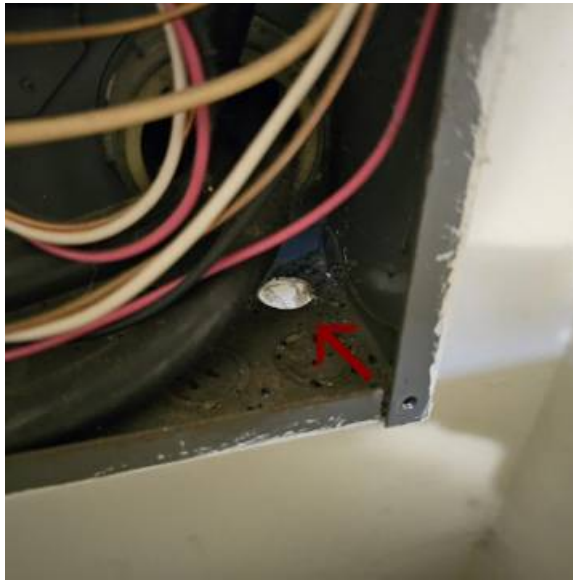
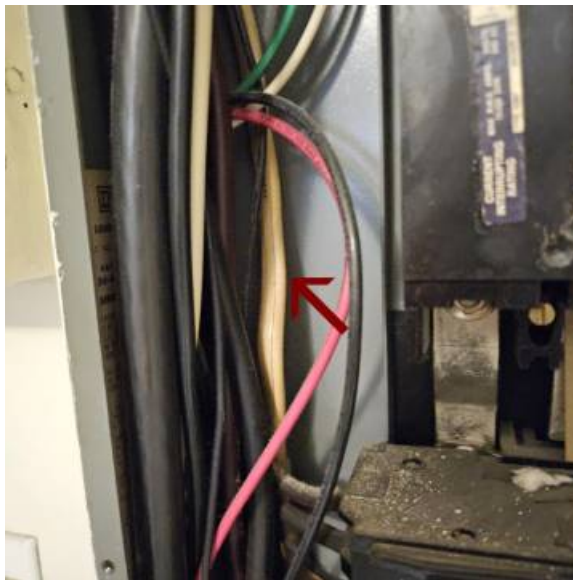
UTILITY ROOM PANEL: The sub panel cover was removed for inspection and the following was observed at time of inspection:

2. Missing covers on openings inside the panel, unused openings at the bottom of an electrical panel present a safety hazard to probing fingers. Small plastic covers made for covering such openings are available at most hardware stores. These should be added to prevent safety hazard.

All item(s) identified above should be corrected by a qualified licensed electrician and make corrections as needed to items mentioned above plus any other defects that may exist in the electrical panel.

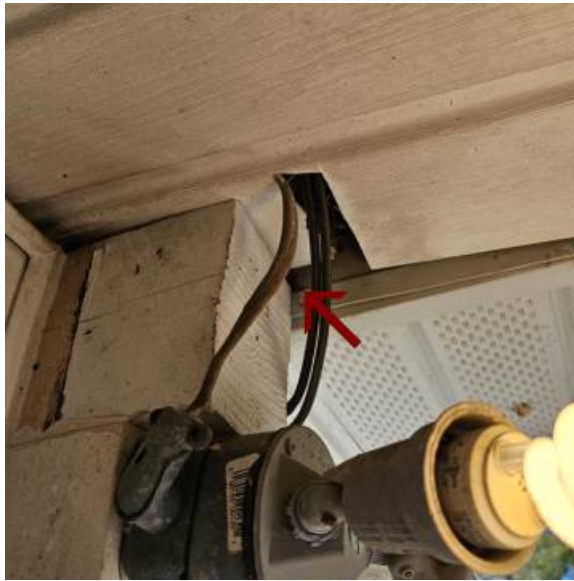
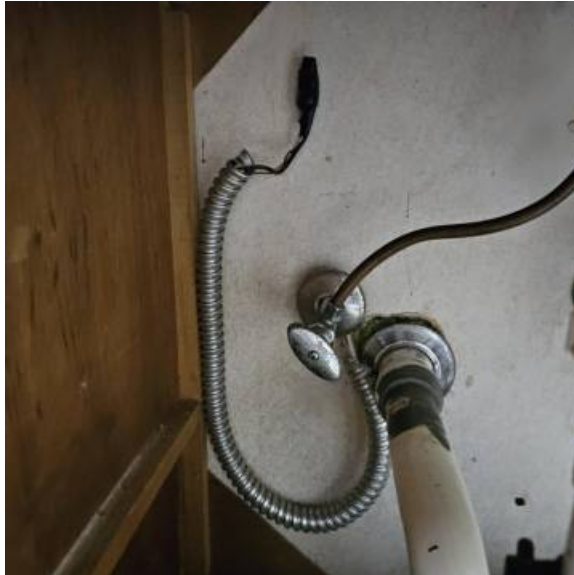
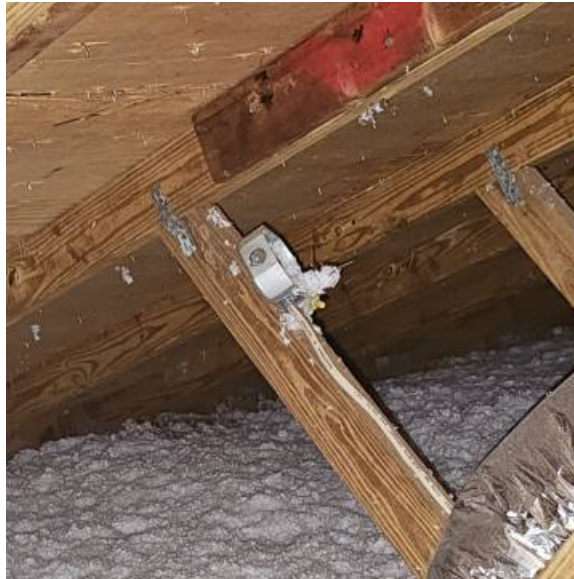
Exposed wires within 7 feet of reach are noted without the benefit of wire protection. This was noted in the following areas:

> attic over the dining room

Where electrical wires join each other in areas other than within a closed electrical junction box, a fire hazard exists. Overheating at any exposed wiring junctions could cause a fire which would spread quickly throughout the house. Electrical junction boxes with covers are used to contain any overheating which may rarely occur. Each of the above areas where uncontained electrical junctions occur should have an electrical junction box and cover installed. A licensed electrician should be called out to add these boxes as needed.

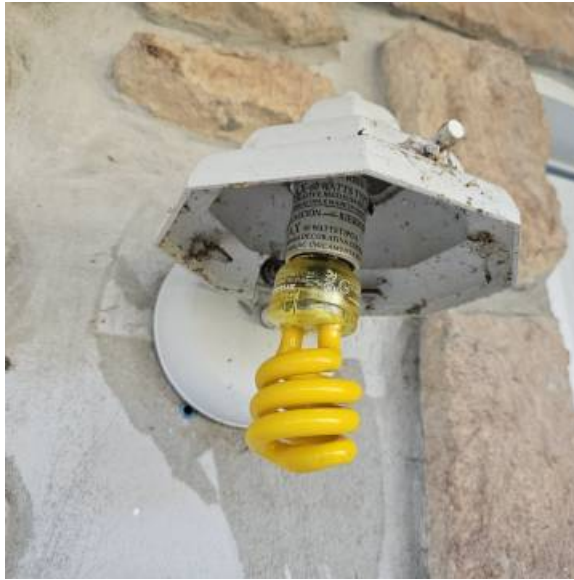
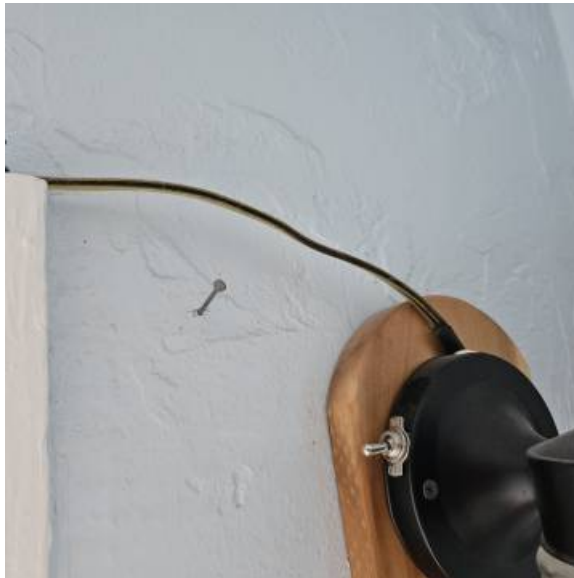
> **inside light fixture near the left side door**
Replacement is needed with approved wiring to prevent electrical hazard.

All item(s) identified above should be corrected by a qualified licensed electrician and make corrections as needed to items mentioned above plus any other defects that may exist.

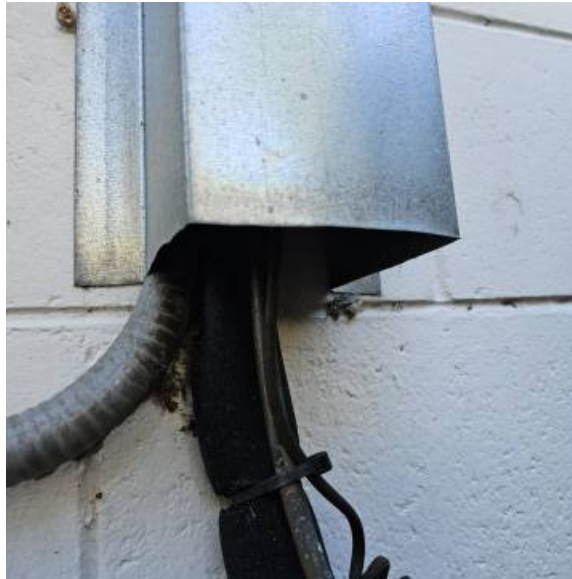
The bottom of the main A/C chase is open, and has the potential to cause rodent activity in the attic space. This should be sealed to prevent access points into the attic. A spray foam or packing is recommended.

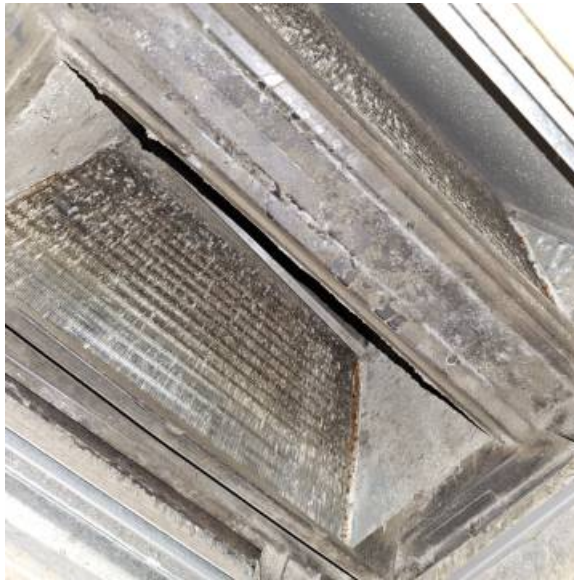
17. The coils for the air handler unit are clogged with excessive debris and is blocking air flow. This will cause the system to function harder and less efficient. Suggest cleaning/servicing the coils to improve air flow. One of the ways in which a dirty condenser coil will affect an air conditioner is to reduce the overall efficiency of the unit. With a condenser coil that is dirty or blocked, the unit will have to work harder to achieve the same results. When the efficiency of the air conditioner is reduced, the unit will also cost the owner more money to operate.

A service call is recommended by an A/C mechanic to clean the coils. This will help improve the performance of the unit.

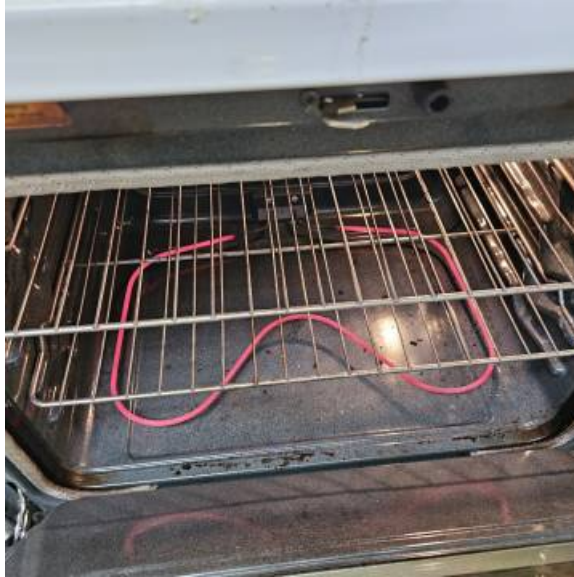
Older appliance, unit is at the end of it's expected life. Expect to replace the unit in the not too distant future.

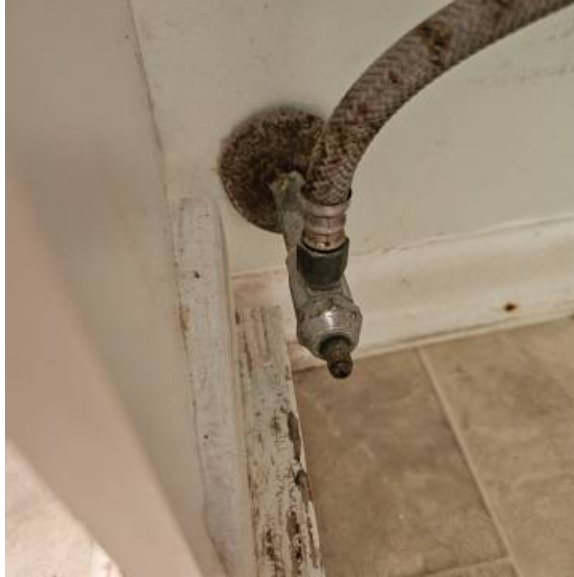
20. Shut off valves/handles are missing in the following locations:

These should be added to shut the water supply lines off when/if needed.

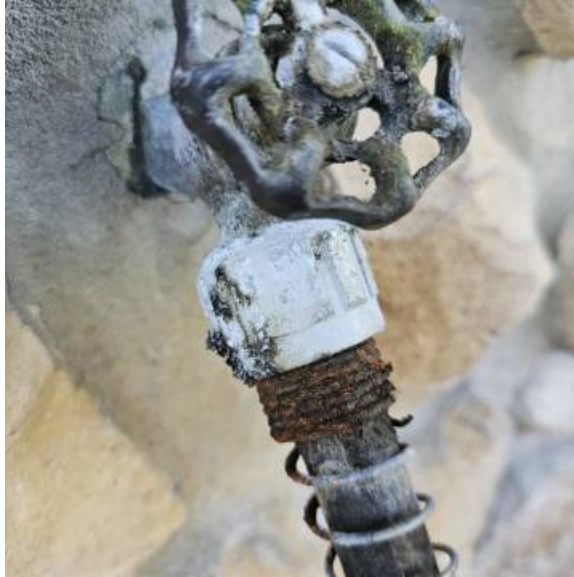
Heavy levels of corrosion is noted to the hose bib in the front of the structure. This may warrant replacement.

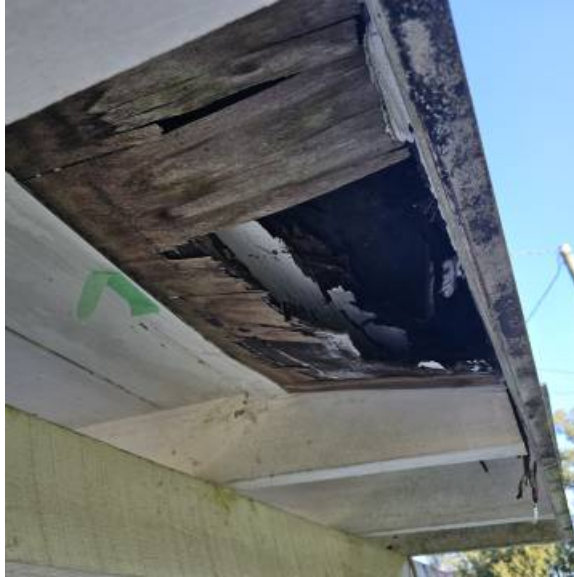
The roof decking is in poor overall condition, where wood rot decay is noted to the wood material. The damaged sections should be replaced as needed.

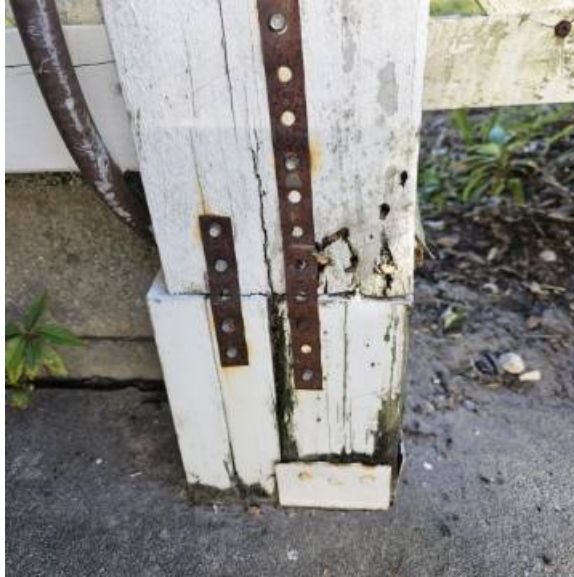
The carport posts are in poor overall condition. Wood rot decay is noted to the base and support integrity from the patching is noted. It is recommend that the columns be replaced with solid material.
