Report: 1656brittain

Building Inspection Report

Date of Inspection: October 24, 2023
Property Address: 1656 Brittain Avenue.
Deland, Florida 32720

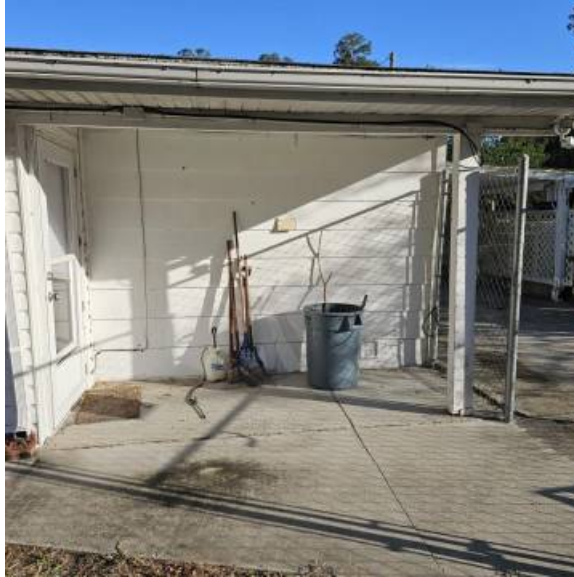
LEFT SIDE: Open design, Same as structure.

1. Deterioration noted at base of posts of the rear porch covering. The column is loose, and should be corrected as needed.

2. Beam damage/wood rot is noted along the top beam over the rear left porch. This should be repaired as needed.

REAR LEFT PORCH: The following was noted at time of inspection:

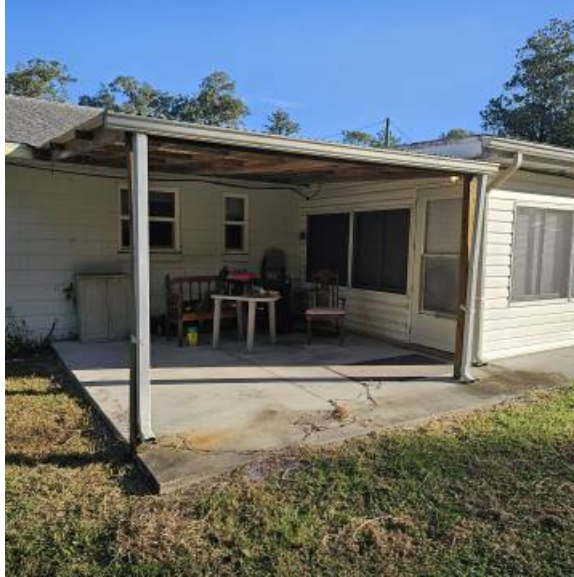
Open design, Fiberglass panels.

REAR RIGHT PORCH: The rear right porch construction was completed in such that does not meet proper requirements. The framing is not properly attached to the header along the main wall properly; the header and beams are secured with a screws (screws are not designed to maintain levels of weight).

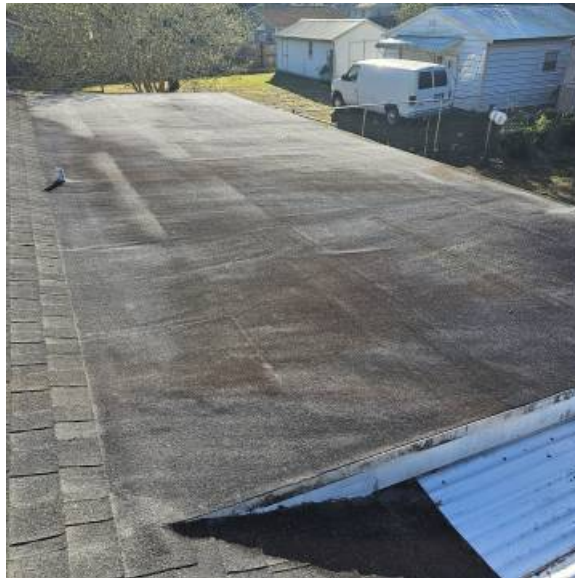
Walked on roof, The roof appears to be between 12 to 15 years of age.

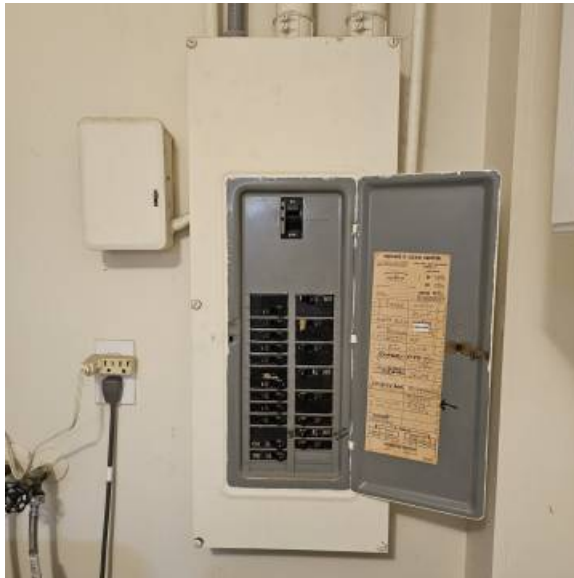
Panel was manufactured by, Square D, with matching circuit breakers. This is original to date of construction.

1. Added wire is noted inside the panel without proper trimming. The wire added has insulation that exceeds the amount allowed inside the panel. This should be trimmed back to the point of entry to prevent overheating.

2. Missing covers on openings inside the panel, unused openings at the bottom of an electrical panel present a safety hazard to probing fingers. Small plastic covers made for covering such openings are available at most hardware stores. These should be added to prevent safety hazard.

UTILITY ROOM PANEL: The sub panel cover was removed for inspection and the following was observed at time of inspection:

All item(s) identified above should be corrected by a qualified licensed electrician and make corrections as needed to items mentioned above plus any other defects that may exist in the electrical panel.

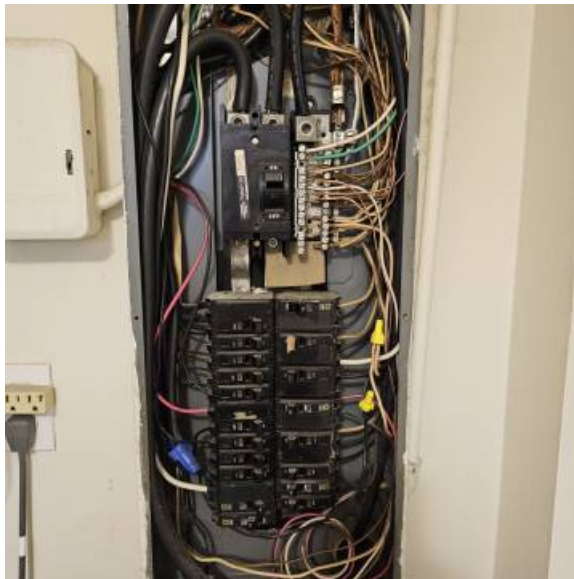
Copper non metallic wire, Good overall condition.

9. Exposed wires within 7 feet of reach are noted without the benefit of wire protection. This was noted in the following areas:

Exposed wires within 7 feet of reach are noted without the benefit of wire protection. This was noted in the following areas:

Unsafe conditions exist and wire protection should be added as necessary.

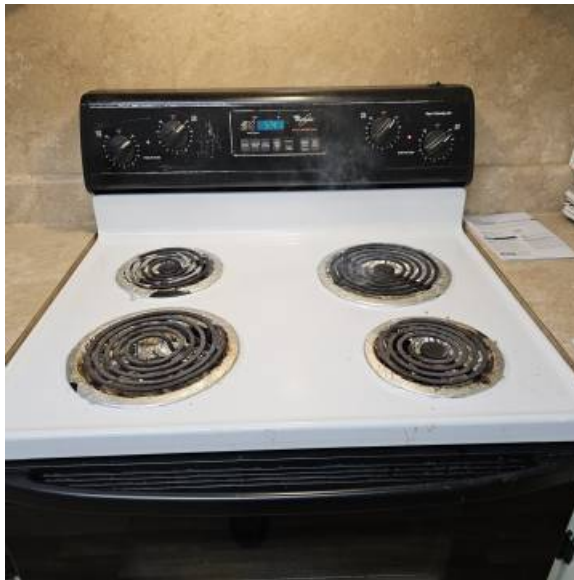
Electric, Combination.

Older appliance, unit is at the end of it's expected life. Expect to replace the unit in the not too distant future.

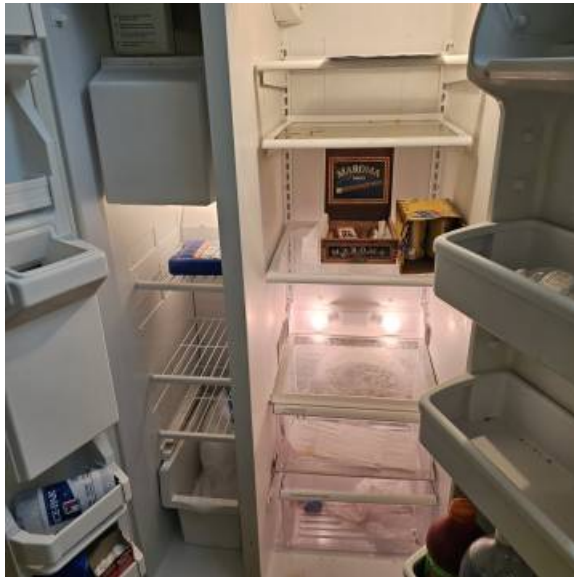
Older model appliance and is at/near the end of it's expected life.
